CANADIAN FORCES FLIGHT SAFETY INVESTIGATION REPORT (FSIR)

FINAL REPORT

FILE NUMBER: 1010-12404 (DFS 2-4-2)
DATE OF REPORT: 1 MARCH 2001

AIRCRAFT TYPE: CH124A SEA KING
DATE/TIME: 191415Z JUL 99
LOCATION: SHEARWATER, NS
CATEGORY: "B" CATEGORY

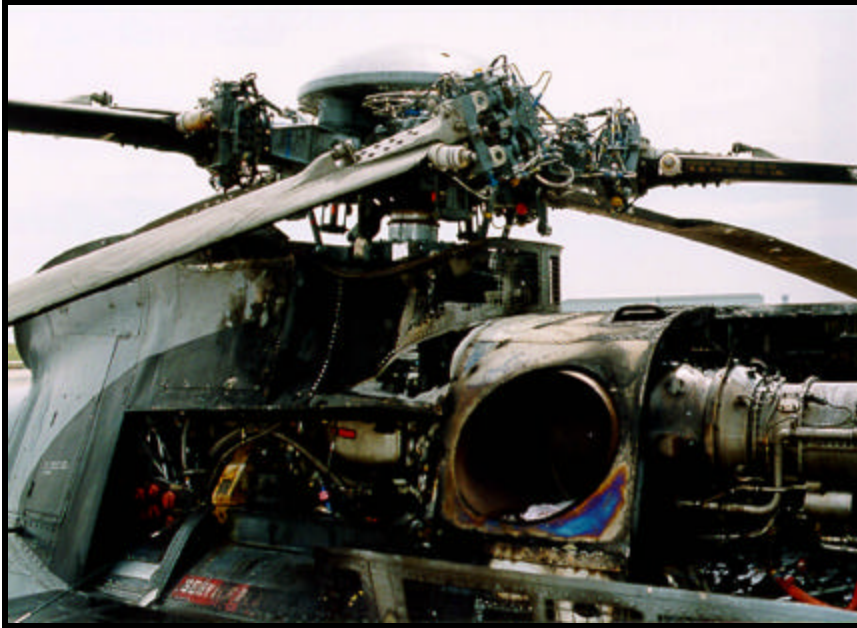
The damage was localized to the upper part of the aircraft between the engines and the transmission (station 202 to station 260). The rear half of both engine access doors were moderately damaged by heat (Figure 1). The fuselage around the right side exhaust area was extensively burned. The aluminium panel directly below the exhaust was burned through. The right side transmission access door was severely sooted (Figure 2). The left side had minimal heat damage in these same areas. The transmission cowling (doghouse) had extensive heat damage. The fibreglass panel on the right side was heated to the point where the resin was burned off and the cloth lost some of its shape. The aluminium mesh on the top forward section of the doghouse was burned through. The aluminium panel on the right side below this mesh was completely consumed. The left side of the doghouse was sooted but received considerably less exposure to heat and flames. All utility hydraulic stainless steel lines in the area of the rotor brake were extensively sooted and electrical wire bundles were sufficiently heated to melt the insulation. Some MGB lines from the Quick Change Unit (QCU) were burned through or loosened by extreme heat and there was evidence of MGB oil in the post fire residue. A section of the engine fire extinguisher lines, where they are routed past the rotor brake assembly, were

completely melted. The cabin roof directly below the forward area of the transmission was exposed to sufficient levels of heat to burn off the paint, discolour the fuselage skin and deform at least one stringer in the area of station 243.5. The damage was assessed as B Category.

Figure 1 - Burn Damage

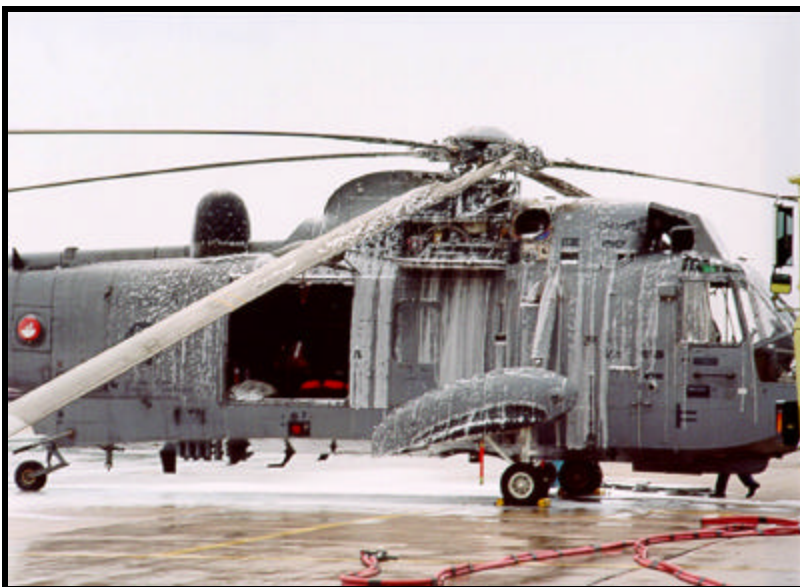
Figure 2 - Right Side Damage

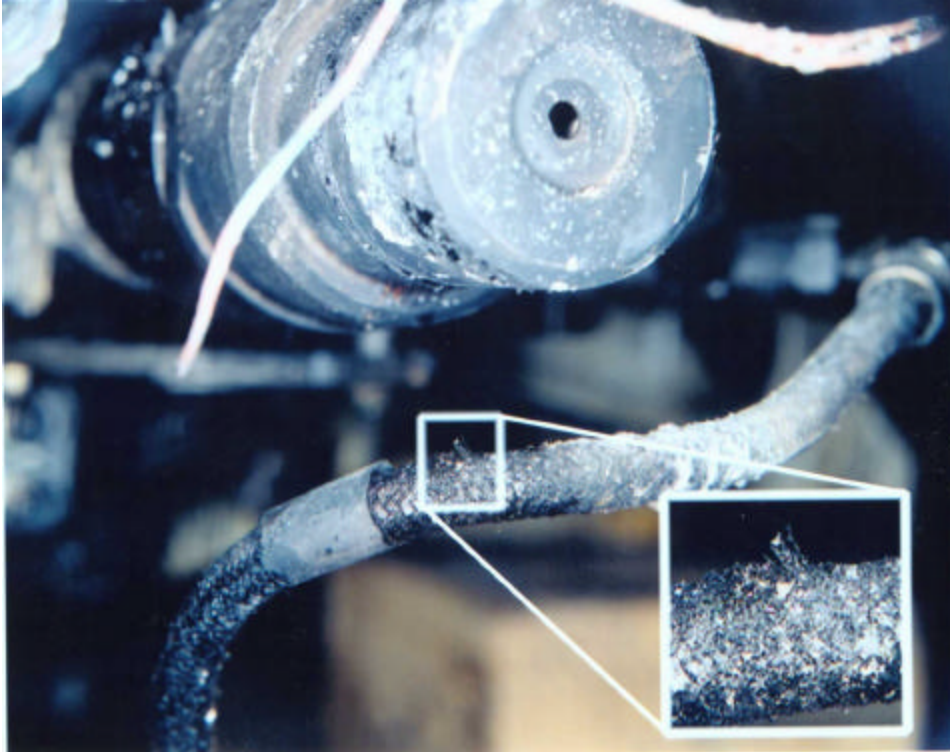
Technical analysis by QETE (Project # D010099) indicated that the hydraulic line providing pressure to the automatic rotor brake (P/N AE24600500E0110) (Figure 3) had been chafing on the "rotor brake panel package accumulator housing" until the line ruptured under pressure. Atomised hydraulic fluid then sprayed on the "number-2 engine power turbine housing" (Figure 4), causing a fire. Actual QETE data demonstrated a minimum time to failure of 100 hours of chafing to rupture the braided steel line (under chafing conditions deemed by QETE to be more demanding than could be expected under normal Sea King flight conditions). From this, and the fact that the MGB had been installed 129 hours prior to the occurrence, it is concluded that the failed line was installed in such a way that it chafed on the rotor brake accumulator housing, eventually resulting in a failure of the pressurised hydraulic line.

Figure 3 - Ruptured Hydraulic Line

3.2.2. Chafing of the "automatic rotor brake pressure line" against the rotor brake accumulator housing caused the hydraulic line to rupture, which then sprayed atomised hydraulic fluid onto the #2 engine exhaust cowling, causing a fire.

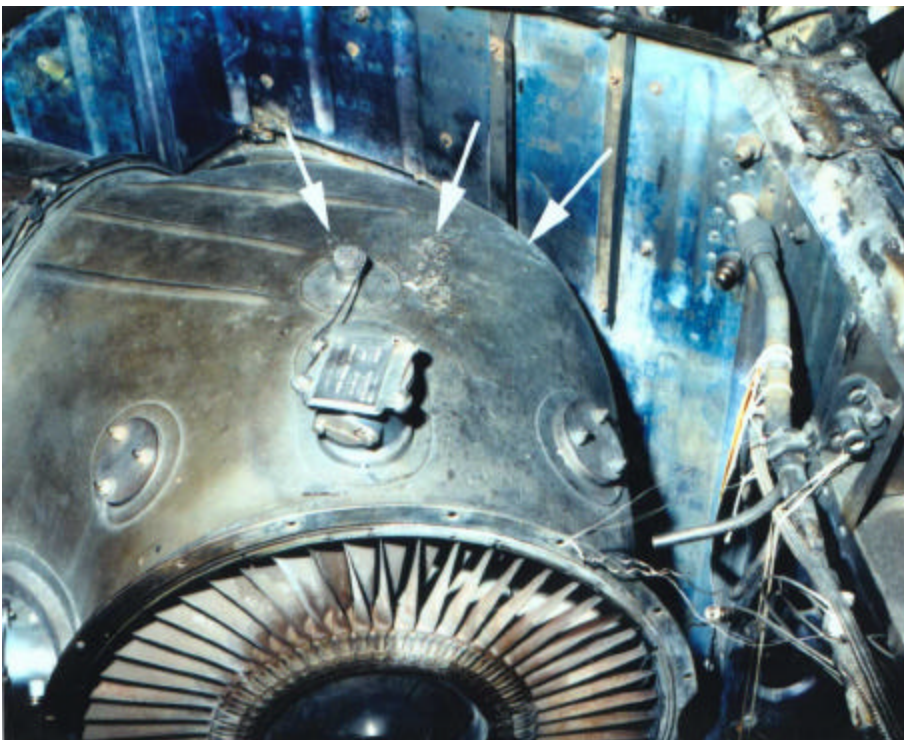
The initial fire was fed by pressurised hydraulic fluid spraying onto the #2 engine Power Turbine Housing, but once the fire was fully established, there was sufficient heat to melt supply lines that allowed other combustible liquids into the area of the fire. The QETE analysis showed that transmission fluid fed the fire in later stages. This is consistent with the fact that the fire seemed to re-ignite after the dry chemical extinguishers were exhausted.

Figure 4 - Ignition Evidence on PT Housing

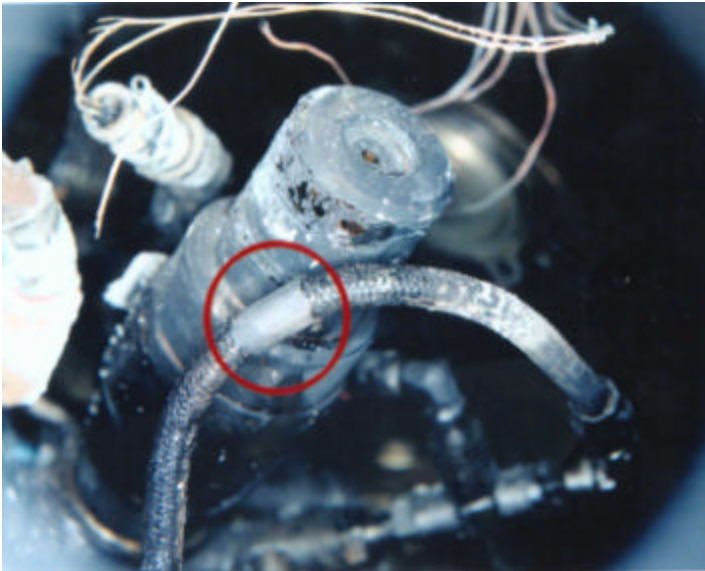
The chafed line in this occurrence is routed directly between the fuselage and the QCU, without clamping. It is connected to a "T" junction, the orientation of which dictates the routing of the hose. Upon installation, line clearance from other aircraft parts must be assured by inspection. Post-installation inspection failed to detect the line-to-accumulator contact.

Upon return to service, the hydraulic line supplying high-pressure fluid to the automatic rotor brake began chafing against the brake housing itself. The location of the affected line made inspection (figure 5 and 6) very difficult, as evidenced by the fact that multiple opportunities for detection (Supplementary Inspections 15 through 20 and a LH engine change) did not result in detection of this routing deficiency. It should be noted, however, that installation of the LH engine requires removal of several panels covering the chafed line, during which time technicians would have had a clearer view of the affected area.

Figure 5 - Line Repositioned to show chafing

4.2.3 It is recommended that DGAEPM consider procedures and/or orders which would decrease the probability of improper routing and clamping and increase the probability of detecting errors in routing and clamping - with priority given to helicopters of the same vintage as the Sea King.

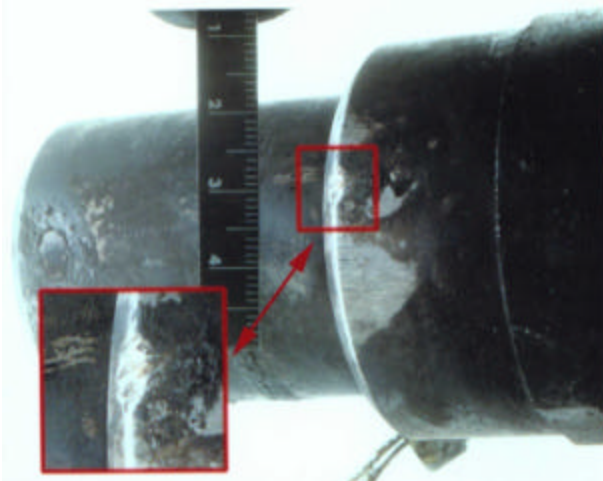
Figure 6 - Accumulator Housing Showing Chafing Damage

- 3.1.6. Improper installation of the rotor brake hydraulic line caused it to make contact with the rotor brake accumulator housing.
- 3.1.7. The automatic rotor brake pressure line chafed against the "rotor brake panel package accumulator housing" for a period in excess of 100 flight hours and probably for the 129 hours since MGB installation, ultimately causing the line to rupture under pressure.

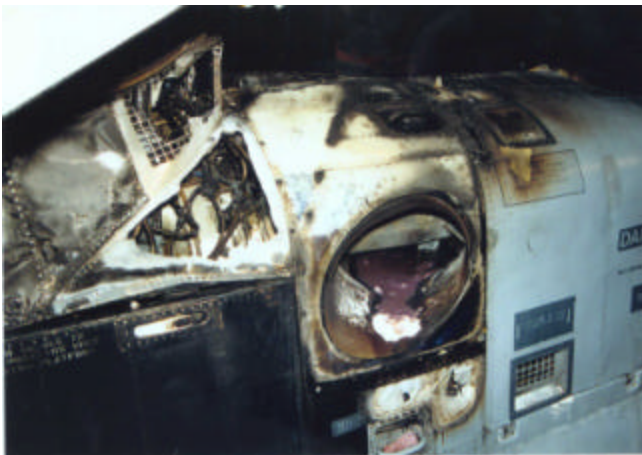
Post-fire analysis indicated that although the source of the fire was not restricted to the engine compartment (figure 7), the fire extinguishing agent supply lines which are routed through the area of the fire, were, at some point in time, completely consumed by fire. Thus, activation of the engine fire bottles might have caused fire-fighting agent to be delivered directly onto the source of the fire through the burned holes in the fire extinguishing agent supply lines.

Figure 7 - Fire damage to Engine and Transmission Area

It was further observed that the fire had developed sufficient heat to melt the aluminium tubing for the fire extinguishing supply lines and to deform the stringer immediately under the MGB. This requires a temperature in excess of 1100 degrees Celsius. The ignition point of the magnesium alloy of the MGB is also approximately 1100 degrees C, but the heat dissipating properties of the magnesium alloy did not permit ignition. The use of dry chemical extinguishers served to control the spread of fire and therefore limited the generalised heating of the magnesium alloy MGB, preventing possible ignition.
